**CITY OF ROCKVILLE HISTORIC DISTRICT COMMISSION  
STAFF REPORT  
for  
December 17, 2009  
MEETING NO. 11-09**

**APPLICATION:** HDC2010-00486  
**ADDRESS:** 401 S. Horners Lane  
Pump House  
**ACCEPTED:** 11/23/09  
**45 DAY LIMIT:** 1/15/2010  
**OWNER:** Mayor and Council  
City of Rockville  
**REQUEST:** Approve exterior alterations, with  
Conditions  
**STAFF:** Robin D. Ziek

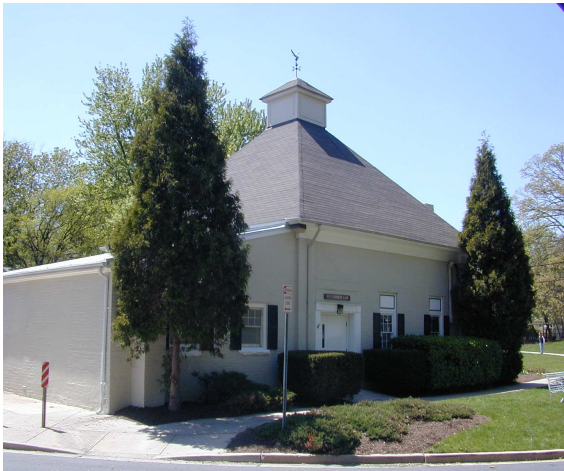
East elevation  
door

The current **front** door, with uneven door leafs, is not an original feature. The size of the original doorway, however, is discernable in the brickwork and with the original lintel at a distance above the current doorway.

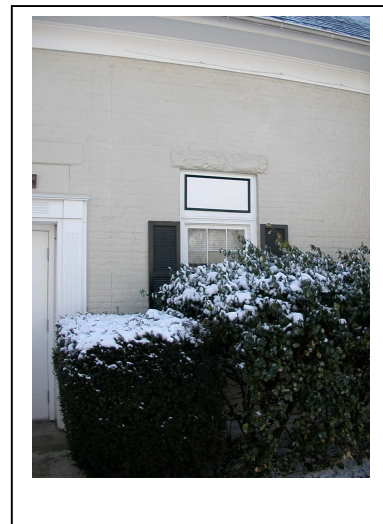
East elevation detail of shrubs by front

The mature shrubs around the Pump House are proposed to be removed, including the shrubs along S. Horners Lane that hide the front (east) elevation of the building and block the front windows as well. Corner evergreens will also be removed. All of this plant material is too close to the building and prevents adequate ventilation of the exterior bricks. In addition, the removal of the plant material will reveal the building to view, and staff urges the HDC to approve the removal of this existing plant material.

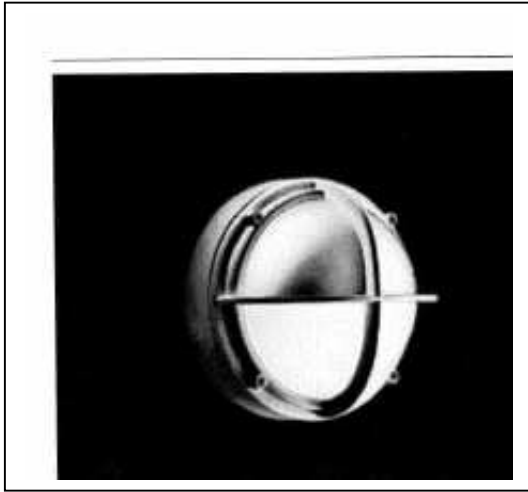
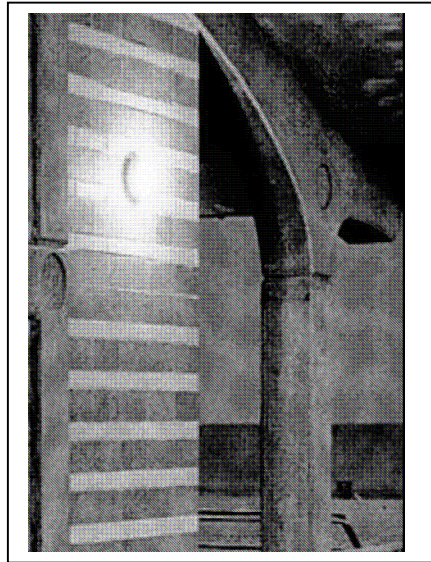
Staff estimates that, despite the cutoff shield at the top, there will be glare from this fixture at the door, and this is not compatible with the residential neighborhood, an element of the environmental setting for the Pump House.

In addition, the design of the fixture itself is out of character with the building and may be jarring. Staff recommends selection of another light fixture that will not replicate Victorian lighting, but more compatible than the proposed fixture. As there are street lights in this immediate vicinity, the fixture by the door need not light up the environs of the building, as much as focus light at the front doorway.
